Confidential

This sample report is presented to you as an example of our work. It is not to be shared with other parties.

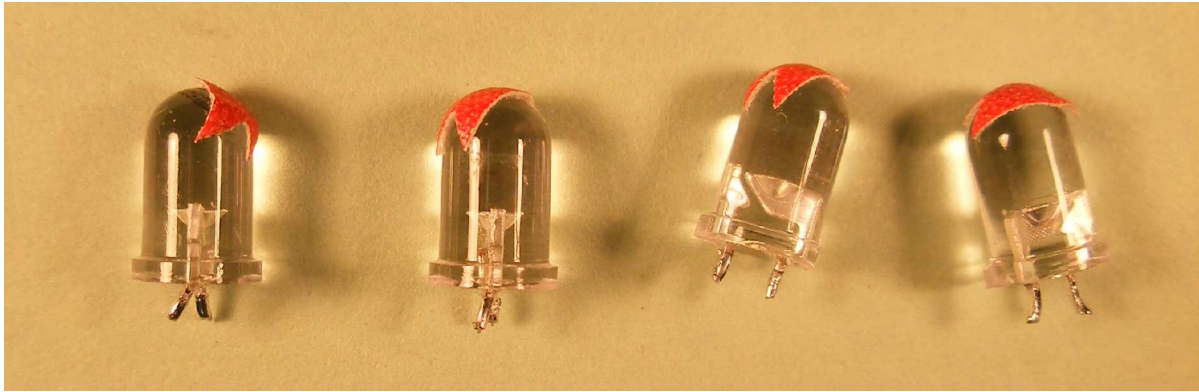
Figure 1a: Four failed LED's received.

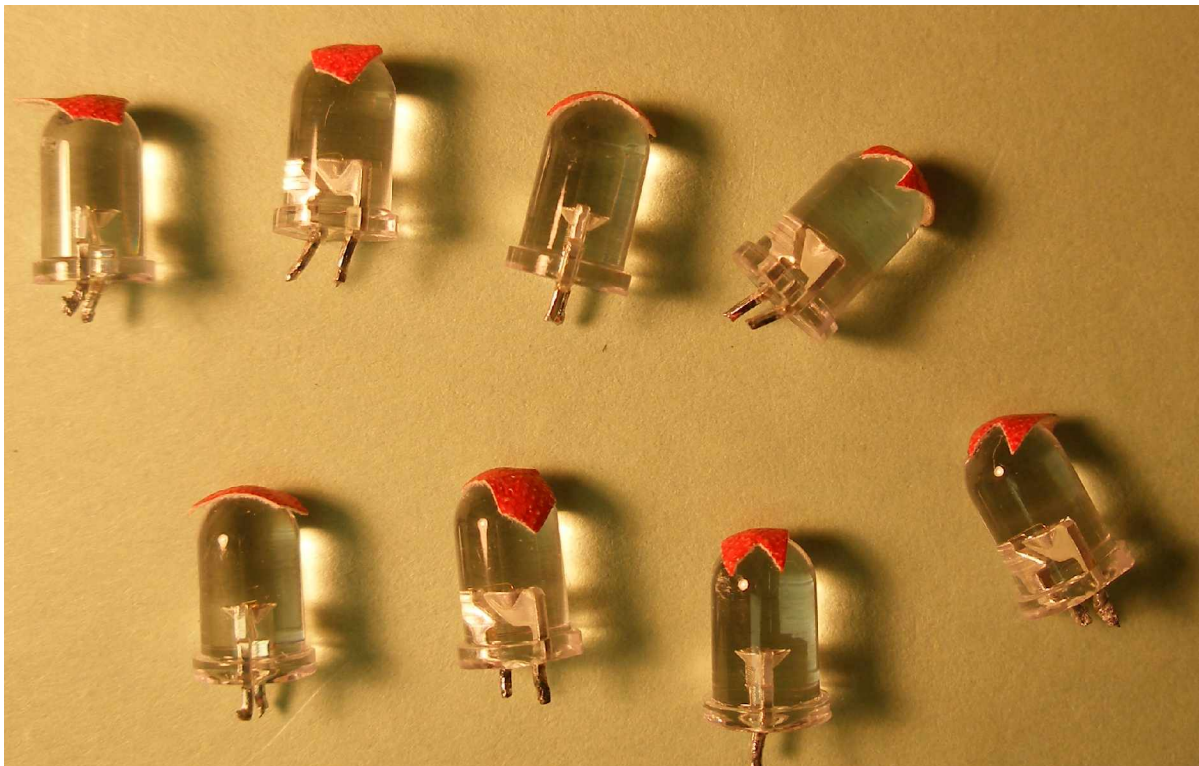
Figure 1b: Eight intermittent LED's received.

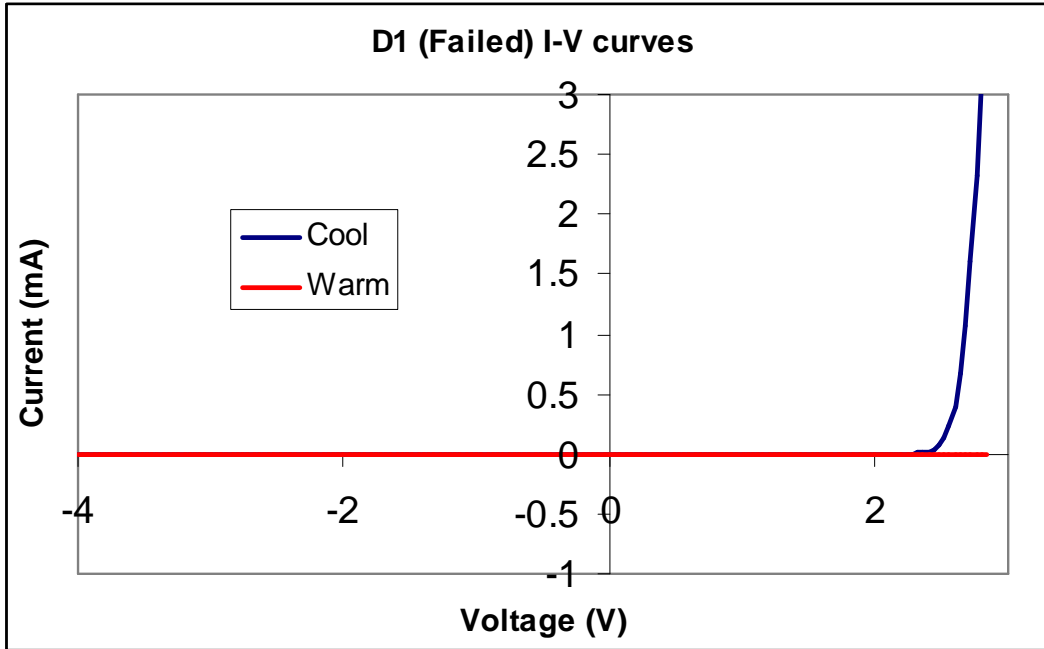
Figure 2: I-V curve of a failed part with and without warming. The part goes open circuit with warming.

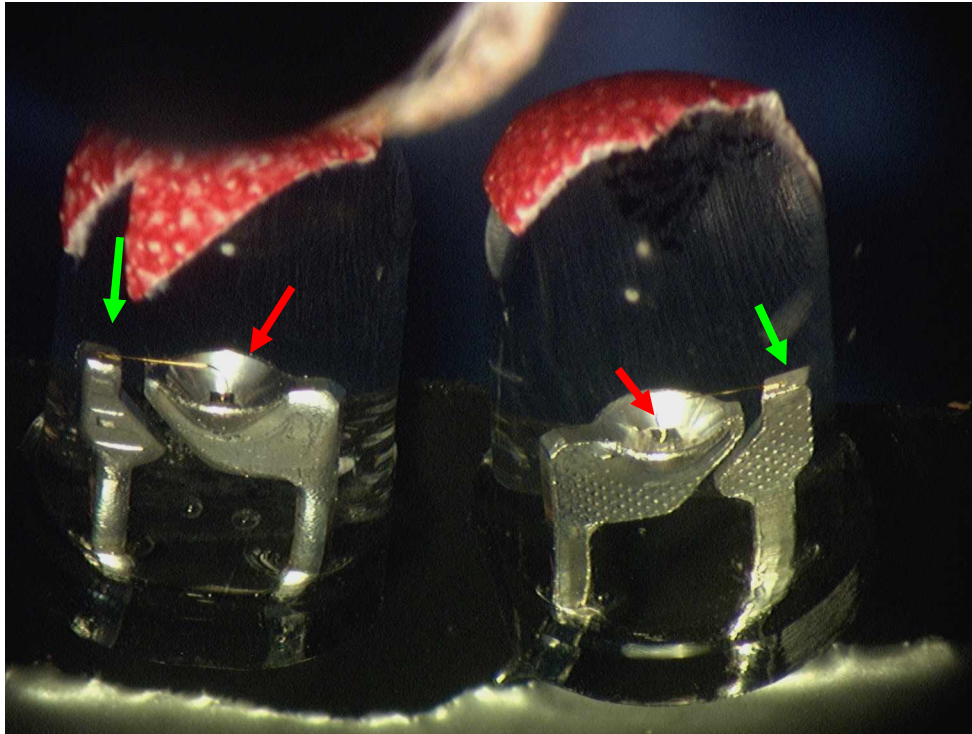
Figure 3: Two failed parts immersed in index matching fluid. The locations of the semiconductor die and the lead frame wedge bond are indicated with red and green arrows.

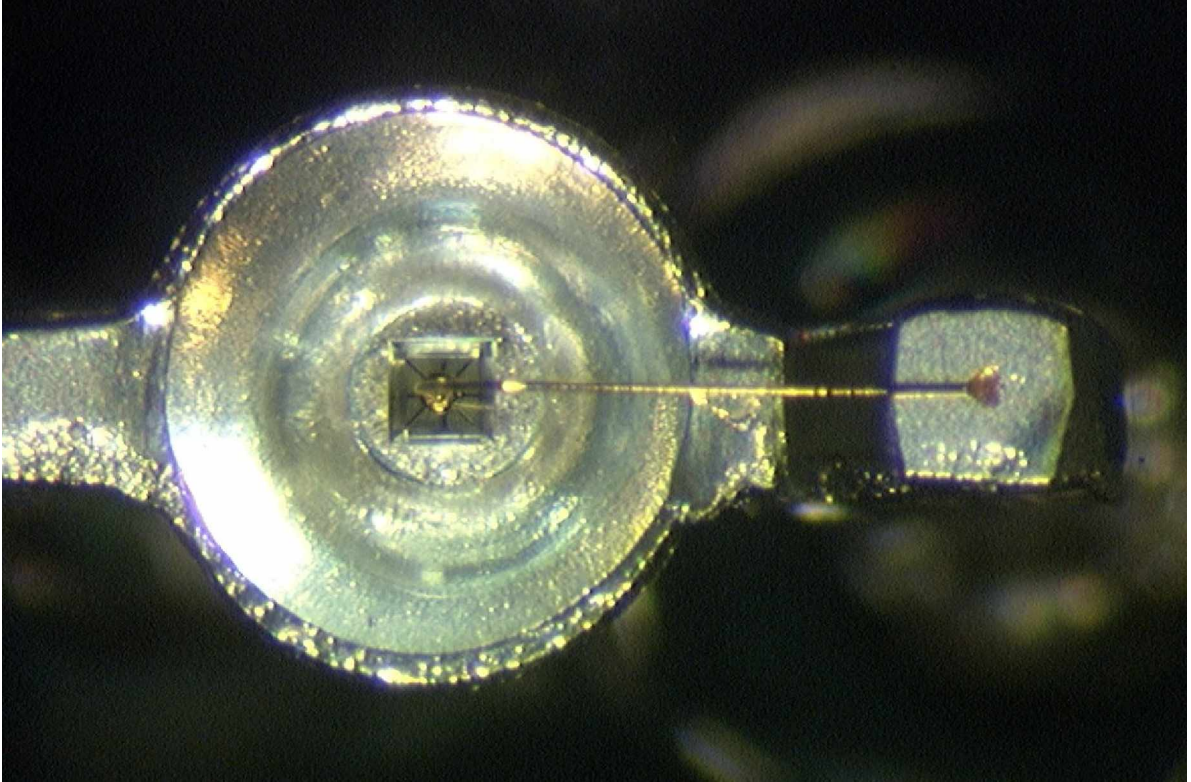
Figure 4a: Top view of die and wirebond of failed part D1, though an optically flat surface polished in the encapsulation. No damage is observed.

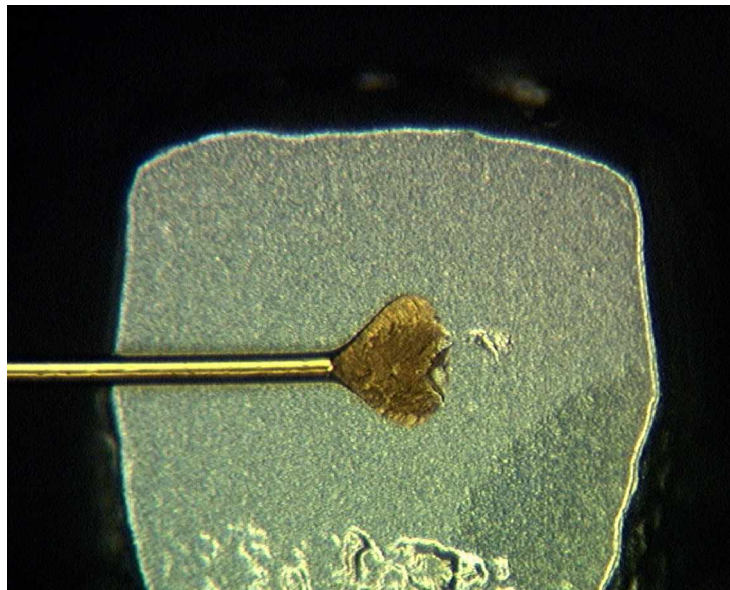
Figure 4b: Wedge bond of D1. No damage to the wire or voids in the encapsulation are observed.

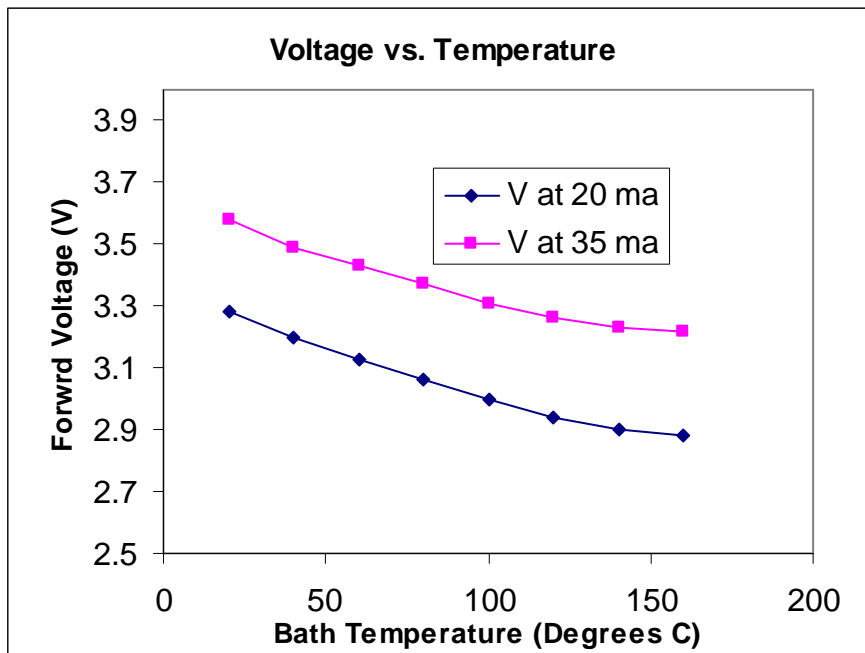
Figure 5: LED operating voltage at 20 and 35 ma as a function of temperature.

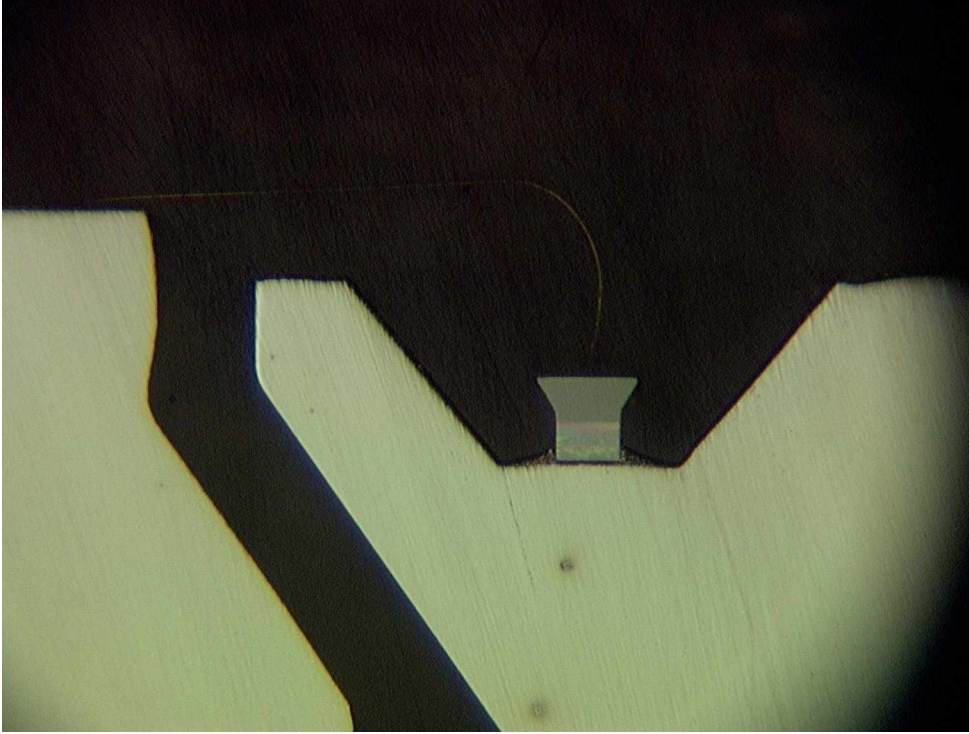
Figure 6a: Low magnification optical image of cross-section of semiconductor die and lead frame.

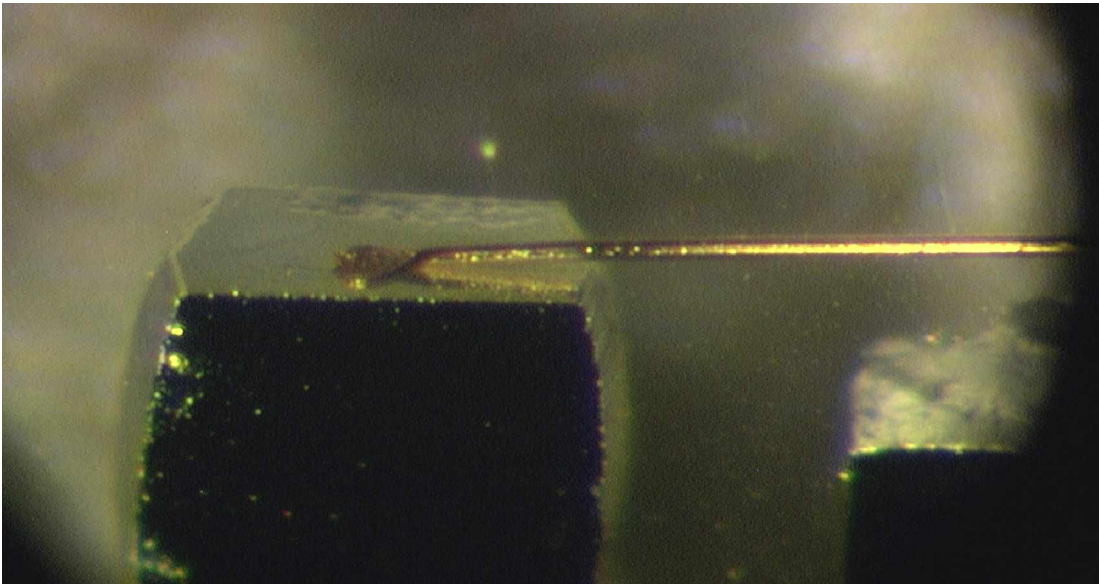
Figure 6d: Wedge bond of D1 observed in a stereo-zoom microscope through the polished surface of the encapsulant. No damage to the encapsulant or bond is noted.

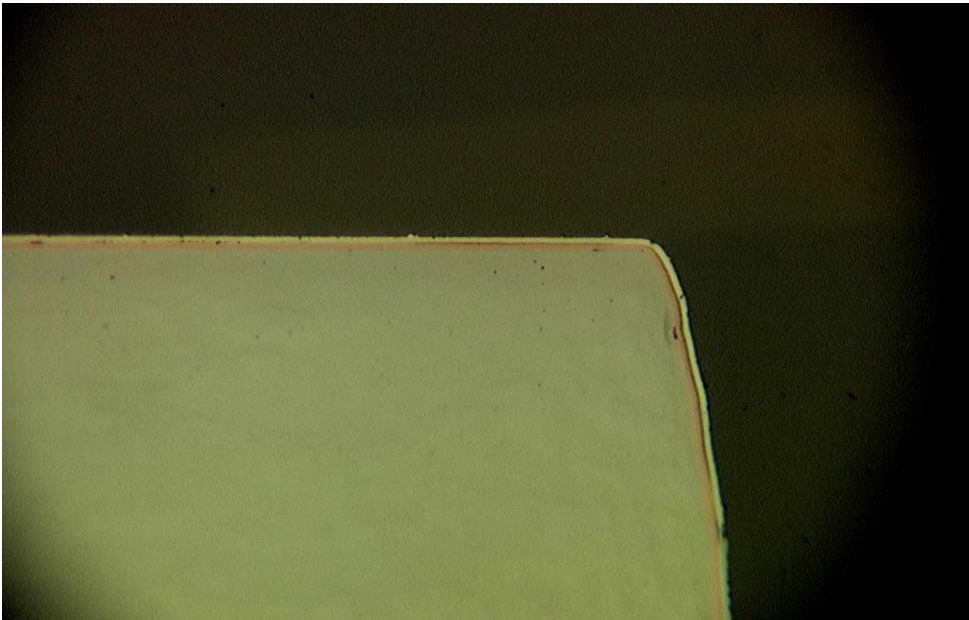
Figure 6e: High-magnification metallurgical microscope image of the Interface between the lead frame and the encapsulant near the wedge bond in the D1 cross-section. The metal platings are clearly resolved but no evidence of delamination is seen.

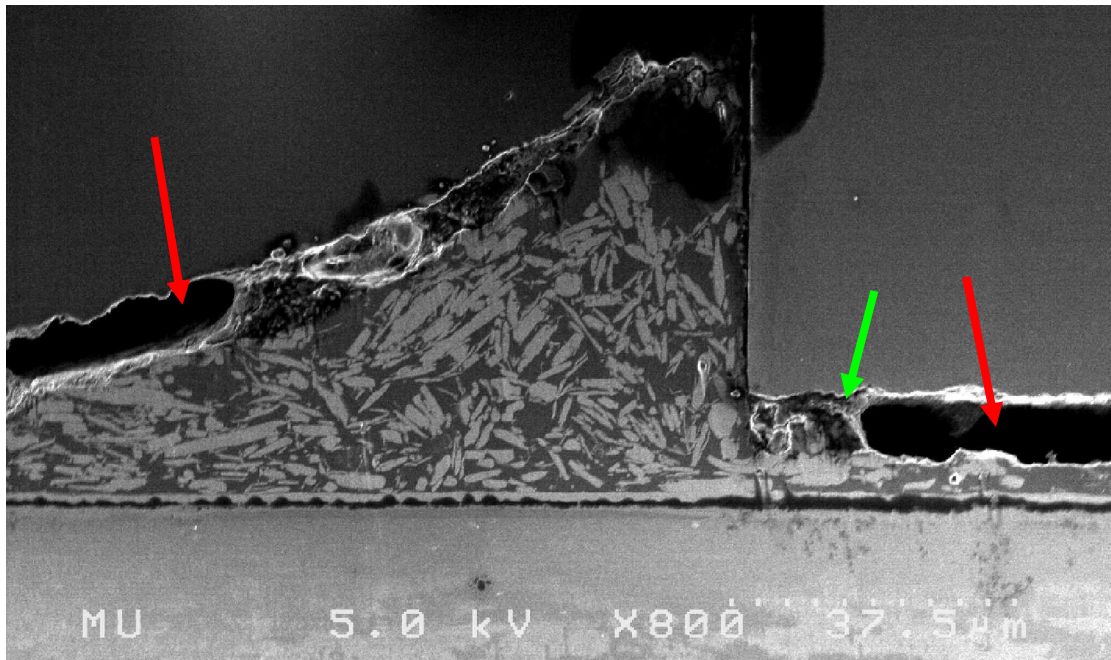
Figure 7a: SEM image of die attach fillet at right side of the die. Gaps (red arrows) are confirmed. There may be some re-melted epoxy (green arrows) but this is not conclusive proof of overheating. At least some of the material in the gaps is polishing residue.

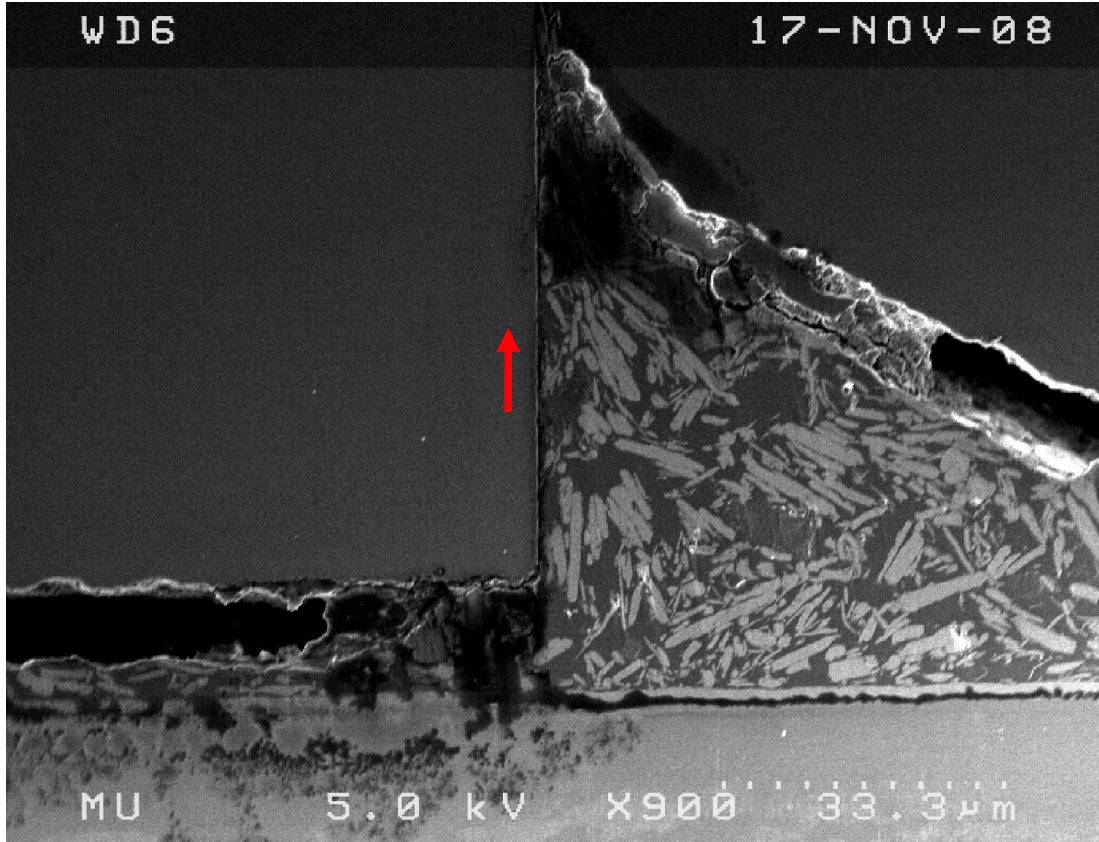
Figure 7b: SEM image of die attach at right side of die. The die has clearly been displaced upward (see arrow) by some force. Note that residues bleeding out of the gaps in the vacuum of the SEM cause dark stains at low beam energy.

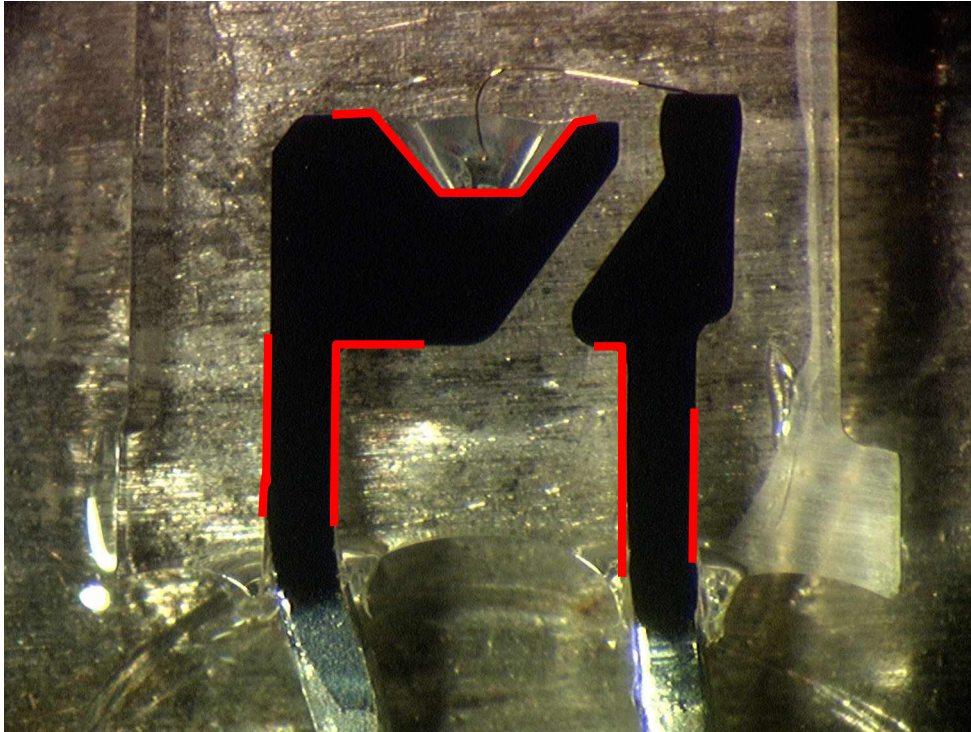
Figure 8a: Cross-section of part I2 with locations of observed delaminations marked in red. Part D1 was similar.

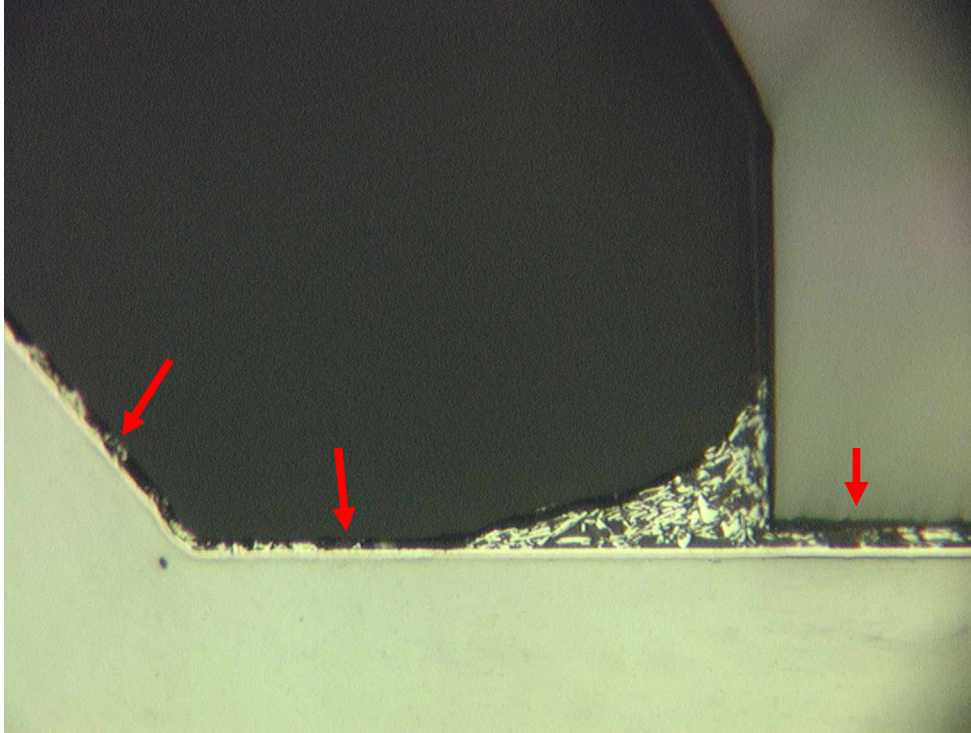
Figure 8b: Delamination of encapsulant from cup and die from die attach in part I2.

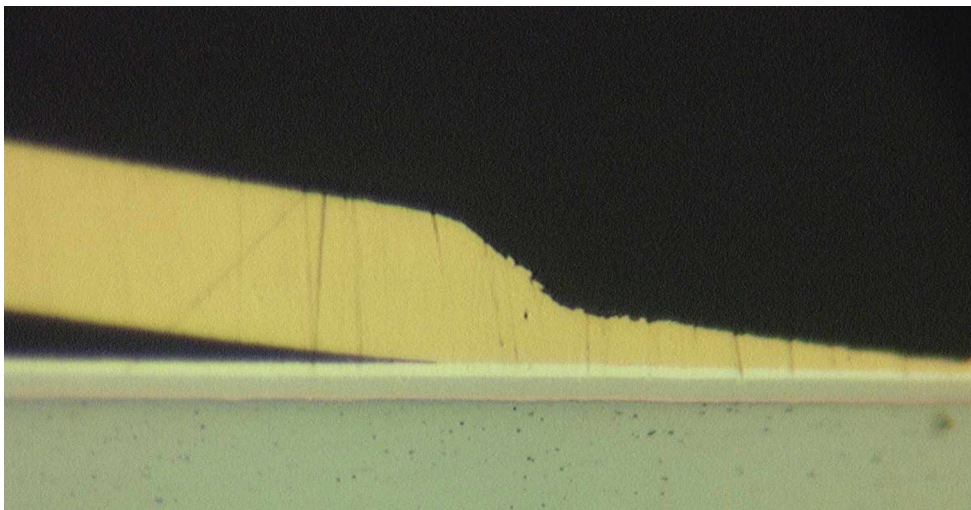
Figure 8: Lead frame wedge bond in cross-section of Part I2.
